Preliminary Failure Modes and Effects Analysis of the US DCLL Test Blanket Module

Lee C. Cadwallader

August 2007

**Idaho National Laboratory
Advanced Nuclear Energy Systems Department
Idaho Falls, Idaho 83415**

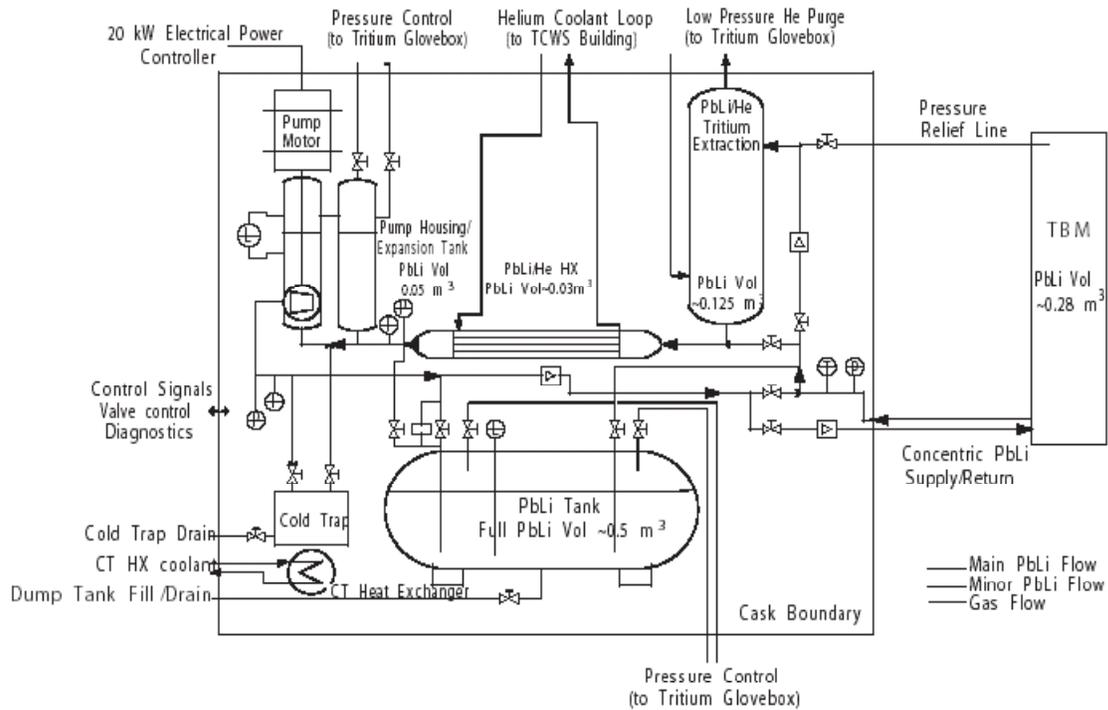
Figure 2-1. The Pb-17Li flow loop of the U.S. DCLL TBM.

The Pb-17Li centrifugal pump is a modest size unit (20 kW or ≈ 25 horsepower), probably a vertically aligned motor to an overhung shaft with either a magnetic bearing or at least a design provision of no mechanical bearing immersed in the liquid metal. The liquid metal will not touch the pump shaft seal; a cover gas (perhaps helium or argon) will be used to provide a cushion to the shaft seal and pressurize the Pb-17Li. The flow from the pump is $\approx 72 \text{ kg/s}$. At 340°C, the density of Pb-17Li is about 9420 kg/m^3 , so the flow rate is $7.6\text{E}-03 \text{ m}^3/\text{s}$ (7.6 L/s). An expansion tank is mounted in tandem with the pump casing. The expansion tank serves two purposes: smooth pressure pulsations and supply extra liquid to compensate for liquid level (keep the impeller immersed). In the pump casing expansion tank, the helium cover gas also provides an opportunity to draw off radioactive gases from the Pb-17Li and route them to cleanup via the pressure control system. From the pump exit, the flow passes a cold trap, which is expected to be

a tank with baffles and wire screens to promote precipitation of impurities and any oxides that might form in the Pb-17Li. The cold trap lowers the Pb-17Li temperature to approach the freezing point of $\approx 240^\circ\text{C}$ but not freeze the alloy. The cooler temperature allows some impurities and oxides to condense out of the liquid alloy. The cold trap can be cooled by forced air, nitrogen, or helium gas; no

special coolants or design provisions are needed for this type of cold trap. Only a percentage of the liquid metal flow routes to the cold trap; other designs have used 5% flow diversion to the cold trap (Spencer 2000). From there, the flow proceeds toward the TBM module. Some flow will always divert into the mixing tank, which is included in the design as a provision to allow high temperature (650°C) operation. From the mixing tank, the flow enters a concentric pipe (inner pipe is the outlet flow, the outer pipe annulus is the inlet flow) that connects to the back of the TBM, cools the walls and breeds some tritium, then flows back out to the flow loop. The outlet flow proceeds to a tritium extraction unit, a vacuum permeator. The permeator is designed similar to a heat exchanger. The high temperature Pb-17Li flow enters tubes that allow tritium permeation through the tube walls, and the vacuum pumping equipment connected to the shell draws the gas away for processing. From the permeator, the hot Pb-17Li (470 up to 650°C) enters a heat exchanger. Helium at 8 MPa in the tubes enters at 200°C and leaves 360°C , and the Pb-17Li leaves at 340°C . From the heat exchanger, the Pb-17Li returns to the centrifugal pump. A drain tank is also part of the flow loop. The 0.5-m^3 drain tank is electrically heated by external resistance heaters to keep the Pb-17Li above its freezing point of $\approx 240^\circ\text{C}$. External heaters were chosen to enhance reliability and maintainability over that of immersion heaters that would be exposed to the liquid metal. The tank is filled with helium gas at 0.1 MPa to prevent moisture or

air intrusion while not in use. A relief valve and a rupture disk will allow flow into the drain tank in the event that overpressure is experienced in the flow loop. The rupture disk is located after the heat exchanger so the Pb-17Li temperature should be relatively constant in that portion of the flow loop. The rupture disk has a rated burst pressure of 3.5 MPa. Rupture disk burst pressures decrease as the temperatures that the disk is exposed to increase, so keeping a uniform temperature enables proper rupture disk performance. A pressure relief valve on the drain tank lifts at 4 MPa (Wong 2005).

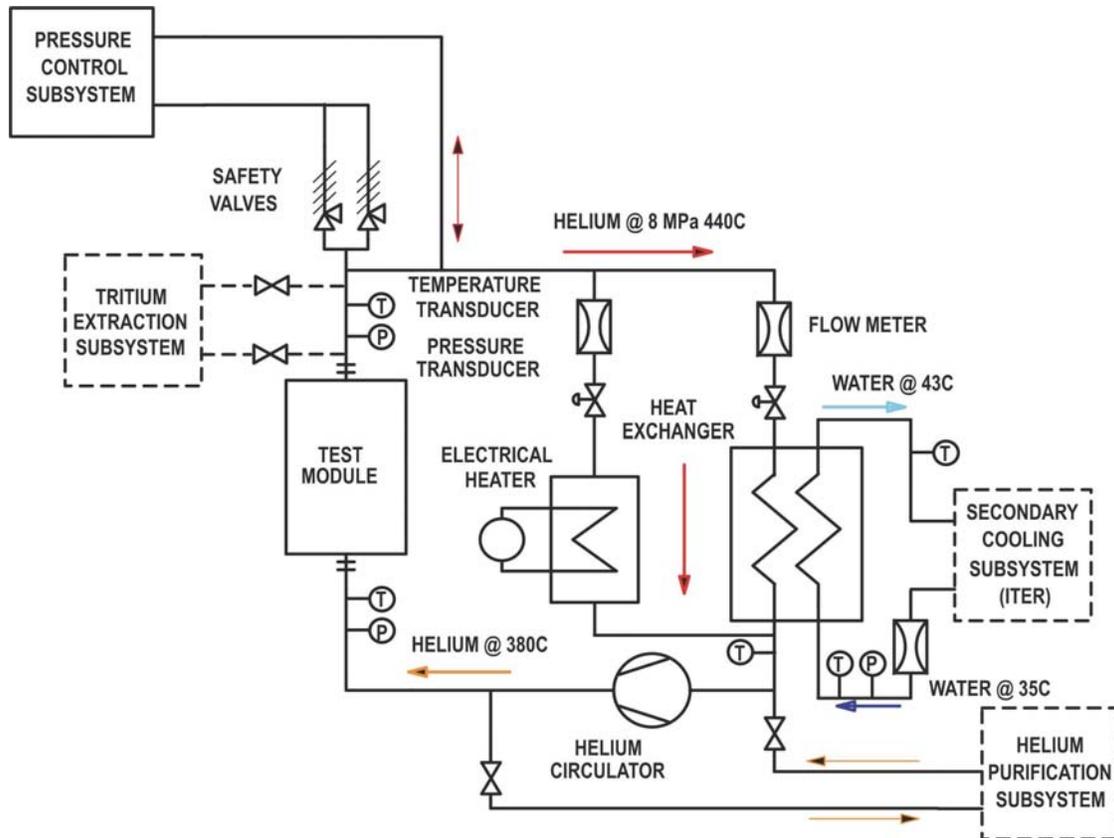
Figure 3-1. The helium flow loop of the U.S. DCLL TBM.
 Note that nine helium storage, four helium dump, and one buffer tank(s) are not shown.

The main components of the TBM first wall helium cooling loop are a heat exchanger, electrical heater, control valves, and pipework. The electrical heater is turned off during normal operations; it is used to raise the helium to the minimum design temperature. The helium purification system (HPS) is small diameter piping with control valves to control flow. The HPS takes a small fraction of the helium coolant as a bypass flow. The helium purification system removes tritium that might diffuse into the helium coolant. There are no filters in the bypass line (e.g., no dust filters like those used in graphite-moderated Magnox and advanced gas-cooled fission reactors) because there are no recognized sources of dust or other contaminants in the TBM flow loop. It is also noted that the Pb-17Li coolant operates at a maximum of 2 MPa, so if a breach between the helium at 8 MPa and the Pb-17Li occurred within the TBM module then helium would pressurize the liquid metal. The module box is built to withstand such a breach without loss of module integrity (Wong 2005). Any 8 MPa helium breaching into the 2 MPa Pb-17Li will transmit pressure throughout the high temperature (highly fluid) Pb-17Li flow loop quickly, and the noble gas is expected to deposit itself in the headspace of the centrifugal pump casing or its expansion tank. The pressure increase in the Pb-17Li loop could actuate the Pb-17Li rupture disk to the drain tank. If the rupture disk opens, the system will depressurize into the drain tank. It is not clear how the helium system would respond to such a breach—the helium will initially depressurize into the drained Pb-17Li piping, but there is makeup helium available from the pressure control system. With the Pb-17Li drained, the Pb-17Li flow loop would de-energize and present a stagnant branch to the helium flow loop. In theory, the helium pressure control system could re-establish helium pressure and continue to cool the TBM module; however, the effects of the transient on the gas circulator (e.g., low pressure/overspeed trip?) and on the TBM box temperature transient during undercooling may require a shutdown. Otherwise, the helium pressure control system is used when evacuating the helium flow loop in preparation for long outages, for supplying makeup helium, and for system overpressure protection.

The helium coolant flows at 1.76 kg/s. The helium circulator, located on the cold leg of the flow loop, is encapsulated and uses a vertical shaft. The shaft bearings will either be gas lubricated or magnetic; this has not been decided thus far in the design. The design temperature of the circulator is 440°C, with a higher maximum temperature to be determined. The circulator is rated for 8 MPa plus a 10% margin for overpressure control. The circulator can deliver a total mass flow rate of 1.82 kg/s at a head of 0.65 MPa at rated (TBD) rpm speed, with 380°C at the nozzle outlet. The circulator speed and maximum allowable speed is to be determined. Circulator safety trips also need to be determined. The input power to the circulator drive motor is 295 kW (assuming a combined motor and circulator efficiency of 0.68). The circulator and motor dimensions are expected to be 1.54 m in diameter by 1.76 m in height. The gas circulator is expected to give heating power of 80 kW to the helium gas flowing through the unit.

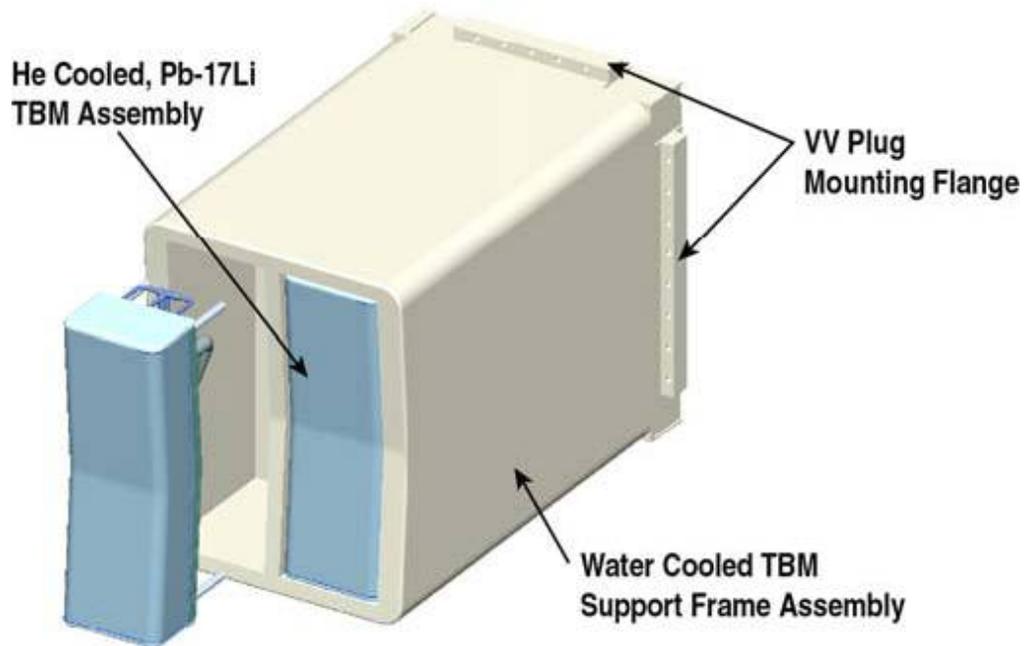
Figure 4-1. U.S. DCLL TBM module front view.

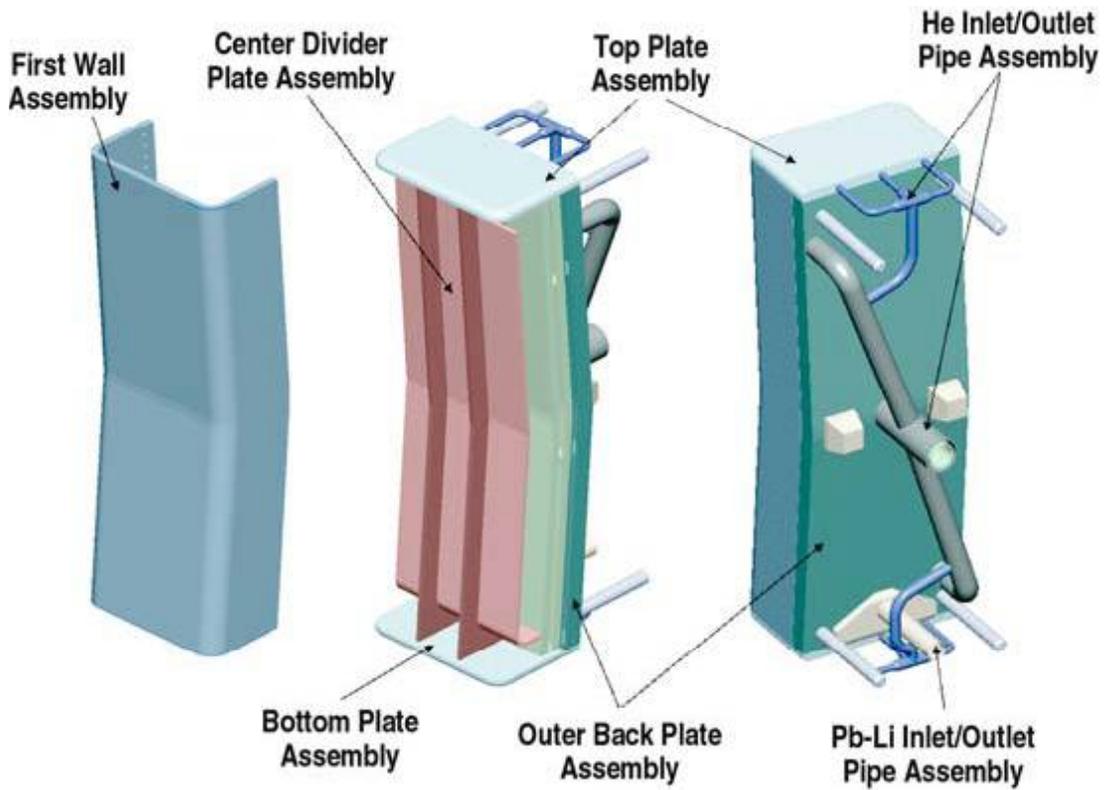
Figure 4-2. U.S. DCLL TBM module box exploded view.

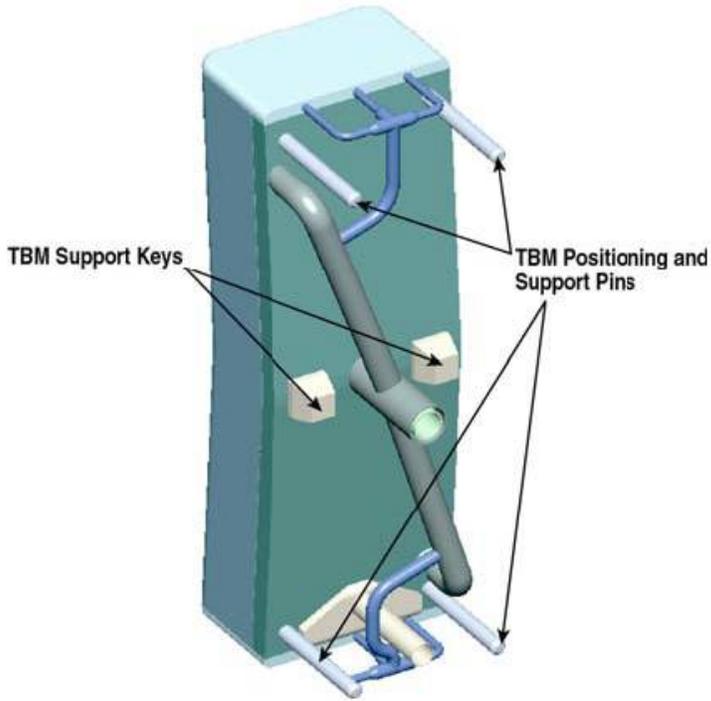
Figure 4-3. U.S. DCLL TBM module box rear view showing support elements.

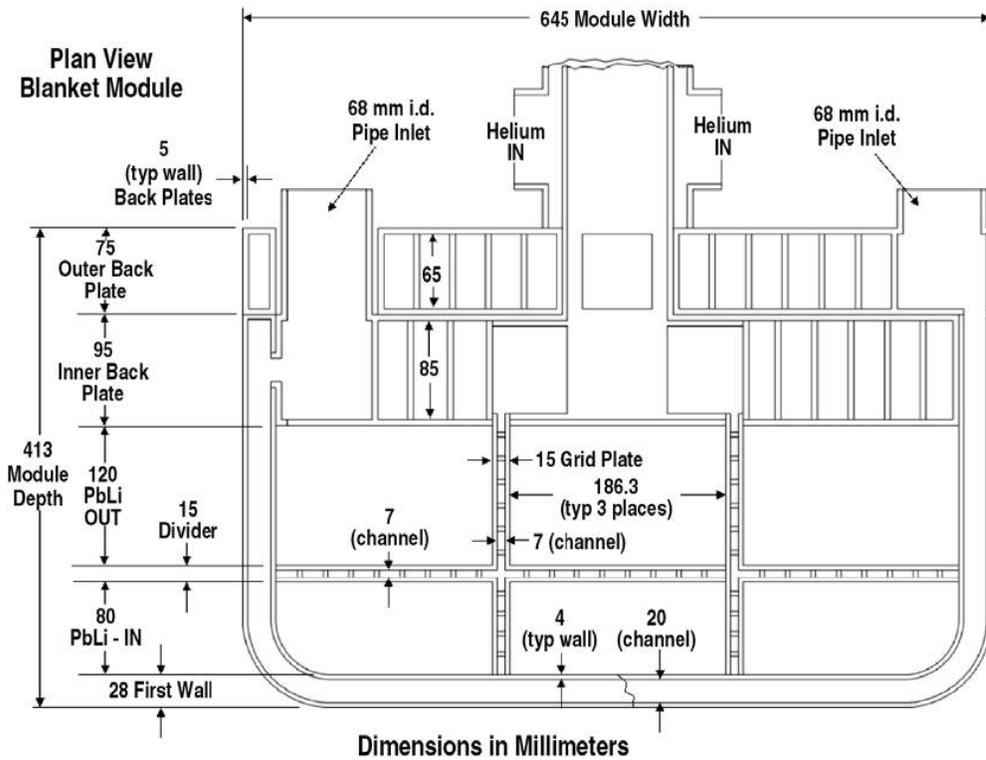
Figure 4-4. U.S. DCLL TBM module box plan view in cutaway.

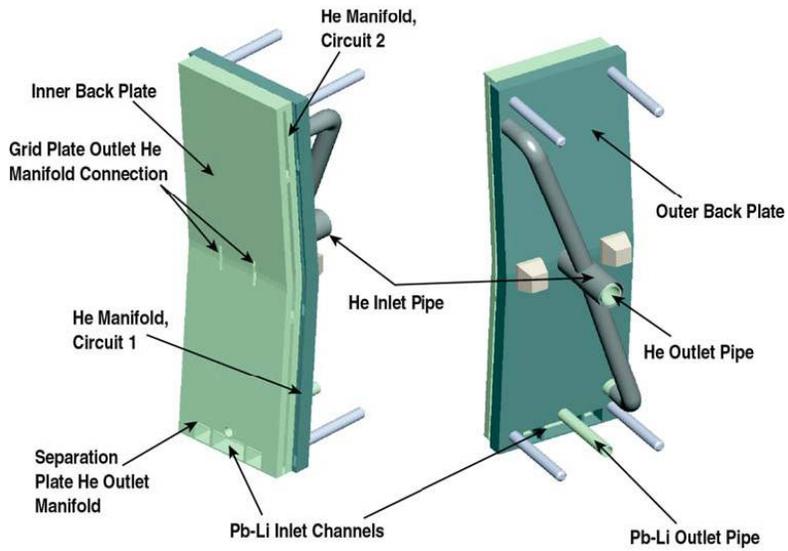
Figure 4-5. U.S. DCLL TBM module backplates and helium gas routing.

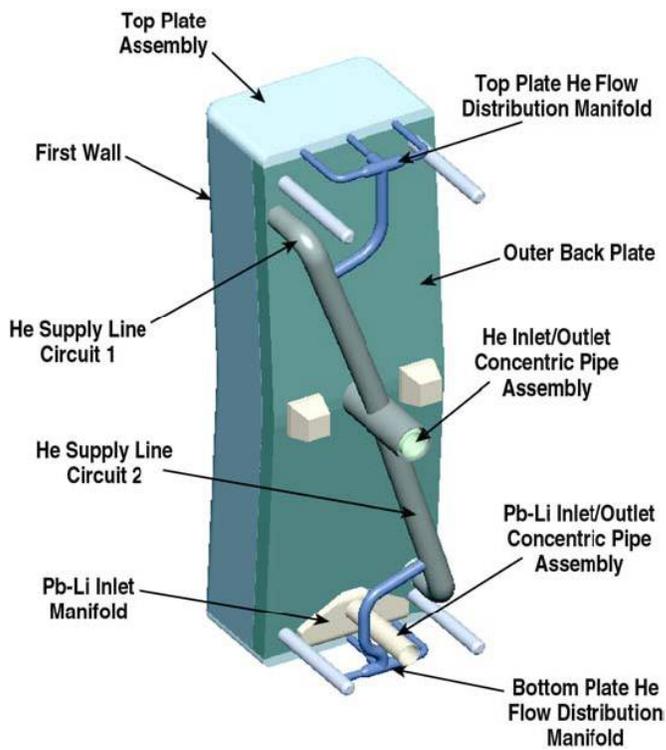
Figure 4-6. U.S. DCLL TBM module box rear view with helium manifolds.

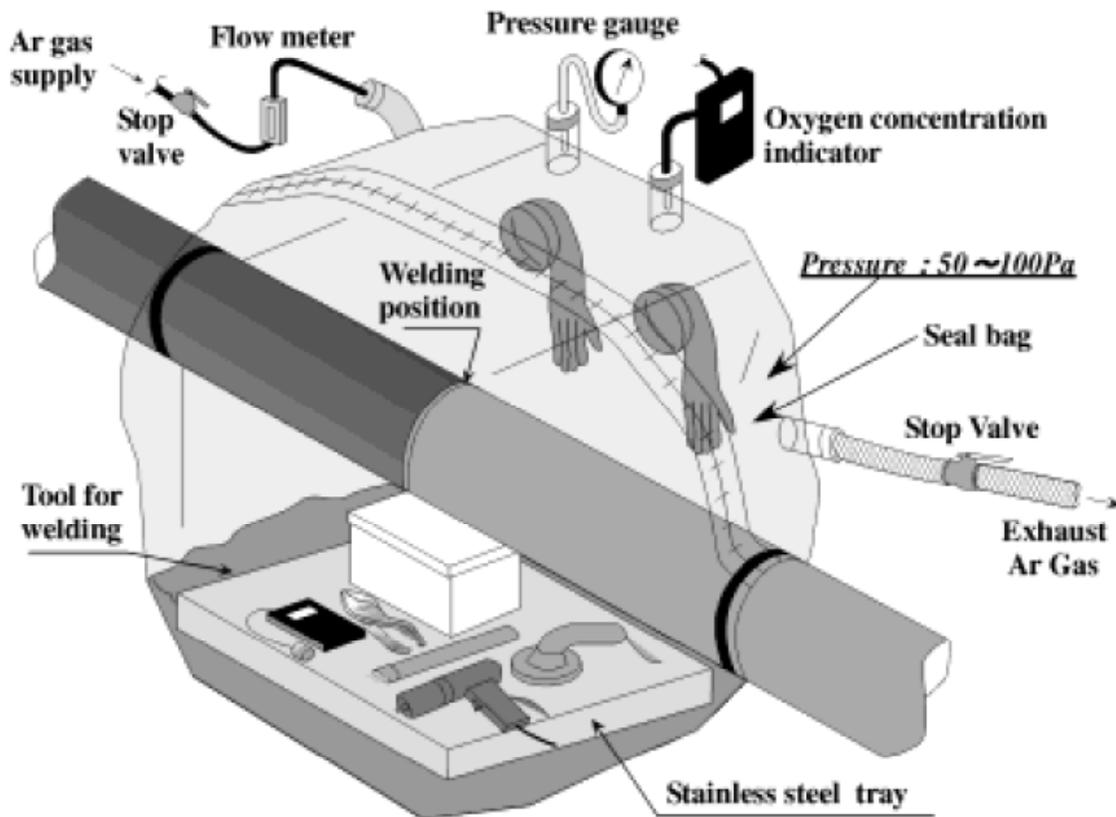
Figure D-1. Depiction of the inert atmosphere seal bag for welding piping. (Isozaki, 2005)
